RE: Site Inspection, Uintah County Asphalt Mine, M/047/022, and Crown Asphalt Corporation, Asphalt Ridge Oil Sands Mine, M/047/032, Uintah County, Utah

Date of Inspection: April 14, 2000
Time of Inspection: 0805 - 1040
Conditions: Overcast, Windy, Threatening Rain
Participants: Jay Mealy, Randy Cloward, Crown Resources; Lonnie Hogan, Uintah County
Tony Gallegos, DOGM

Purpose of Inspection: To discuss the recent site map prepared by the Division and clarify mining and reclamation responsibilities at the site

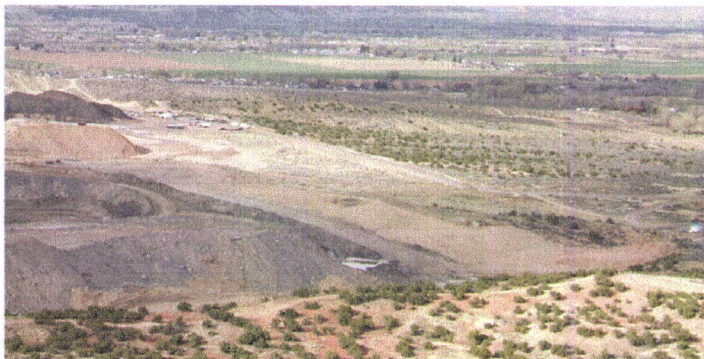
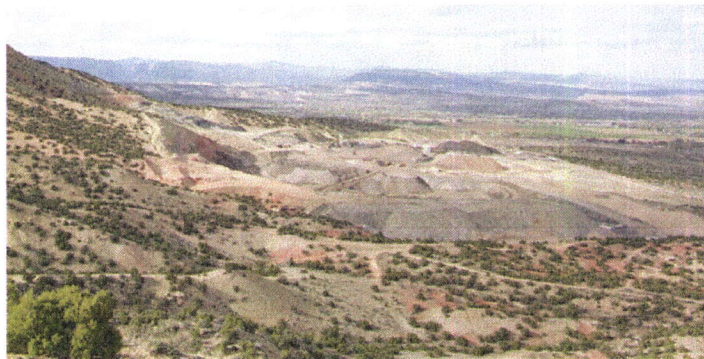
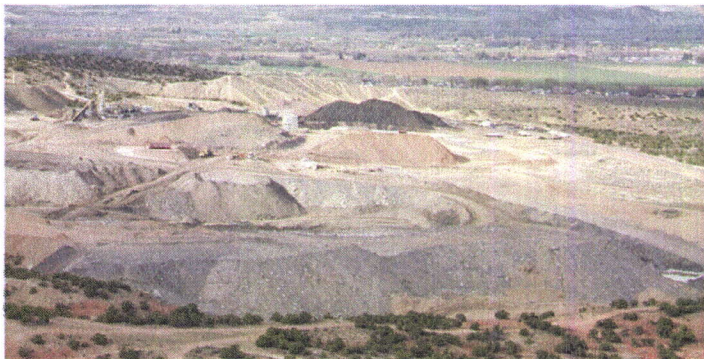
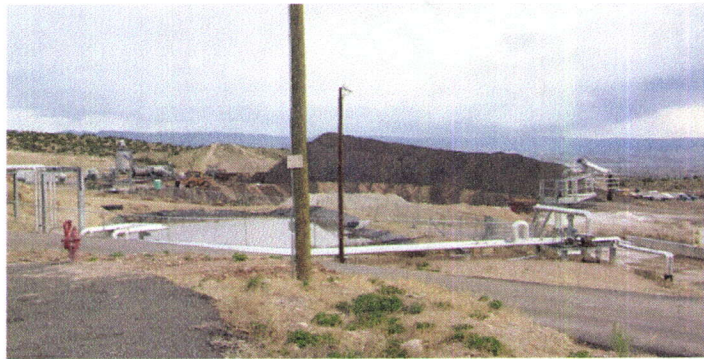
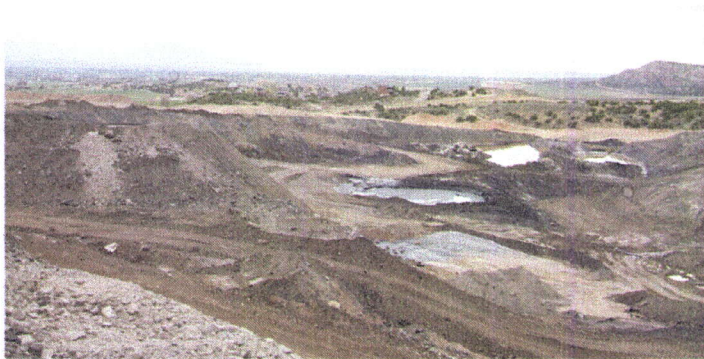
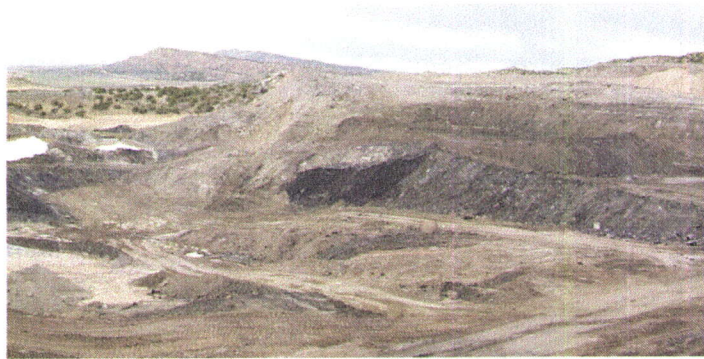
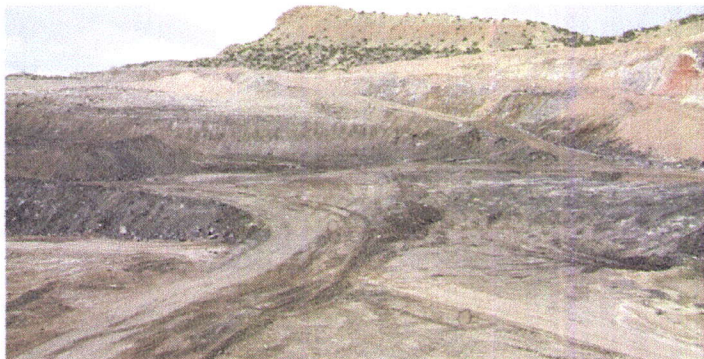
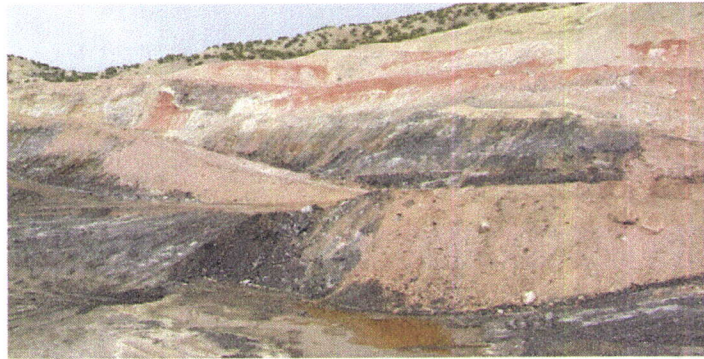
1/4 M/047/032 CRO ASPHALT CORP

Our first stop was overlooking the current pit floor. We were standing on overburden material in the northern half of the pit. This overburden had been moved here from the expansion work located to the south of the pit. We then proceeded to the south end of the pit. Photographs were taken looking northwest and northeast over the current pit disturbance.

We then proceeded to the southeast end of the site near the road gate. This is the road which enters the mine site near the housing area. This road is currently fenced off, trenched and then bermed at the edge of the housing area. This road is also blocked with boulders at the location of the old gate. Photographs were taken showing these various features.

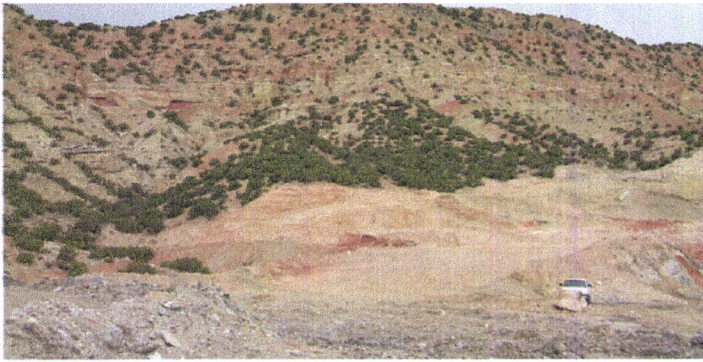
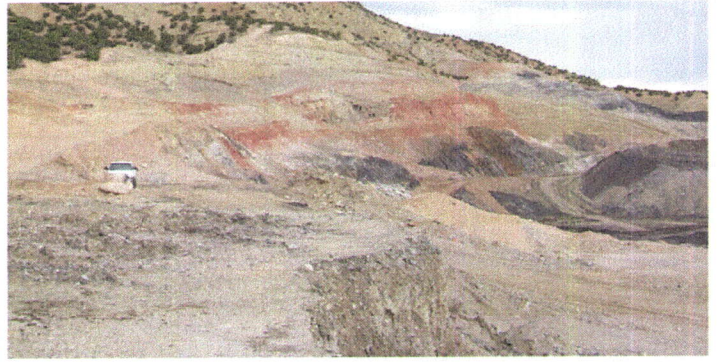
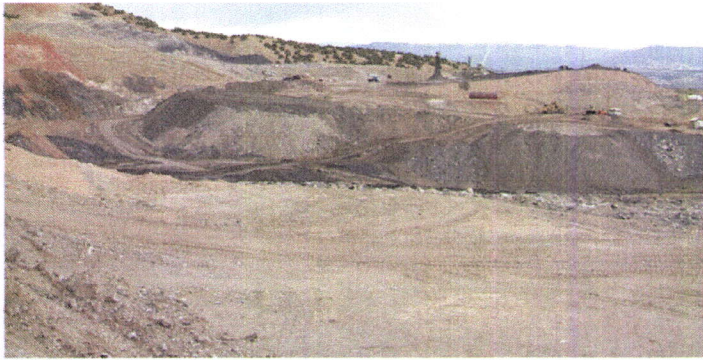
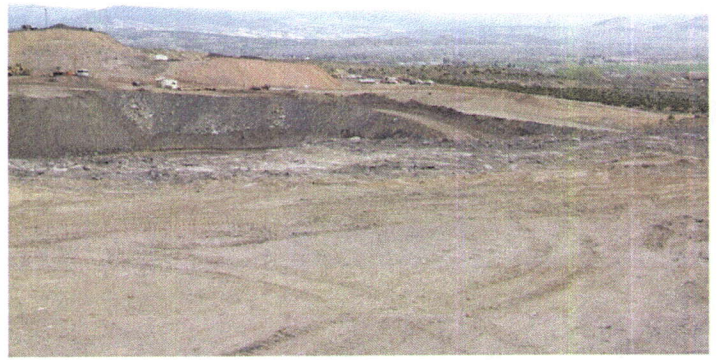
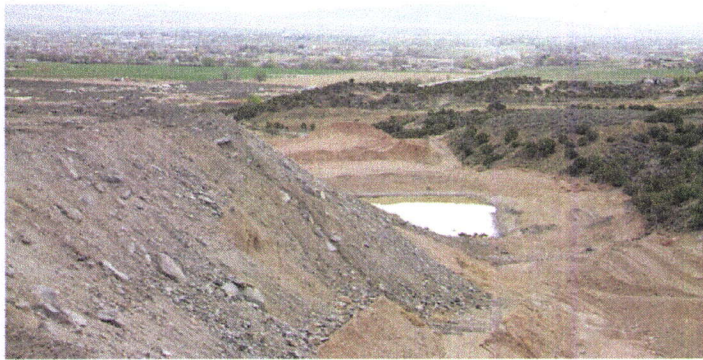
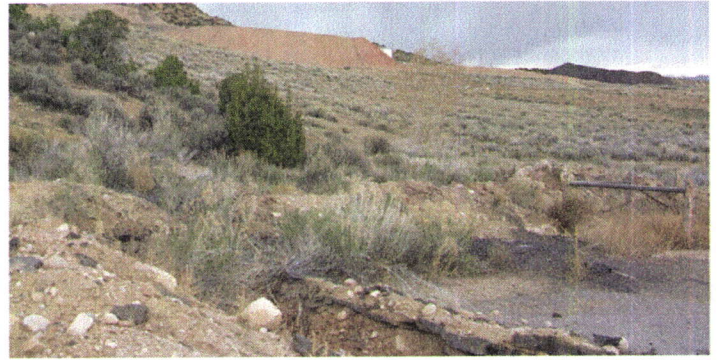
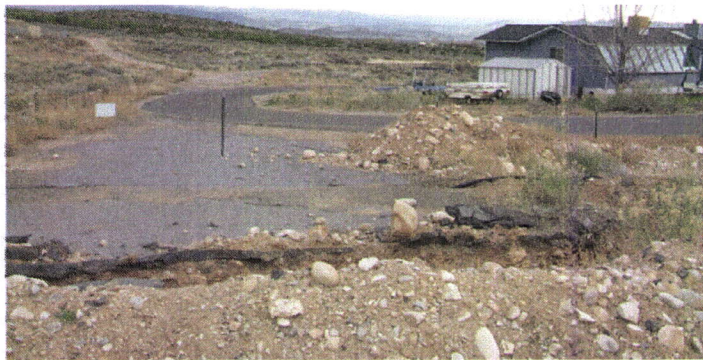
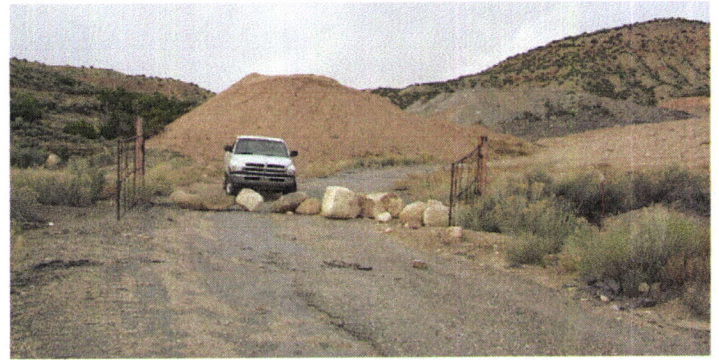
2/4 M/047/032

We then drove to the southern end of the property boundary along the fence line. Photographs were taken of this area showing the fence line, the pit disturbance, and warning signs which have been placed along the fence line. The mine disturbance has not progressed to this area.

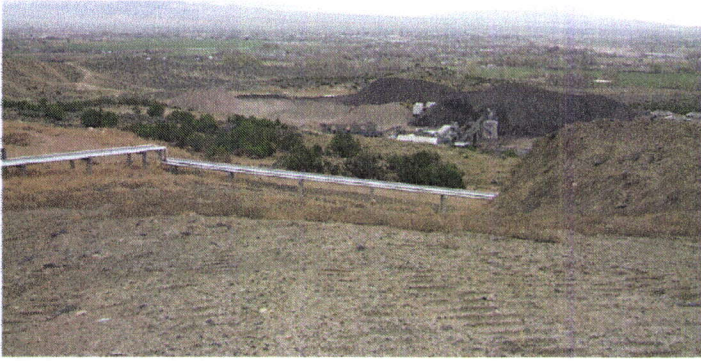
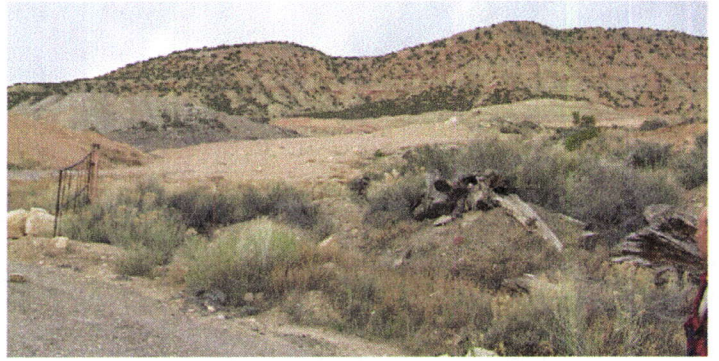
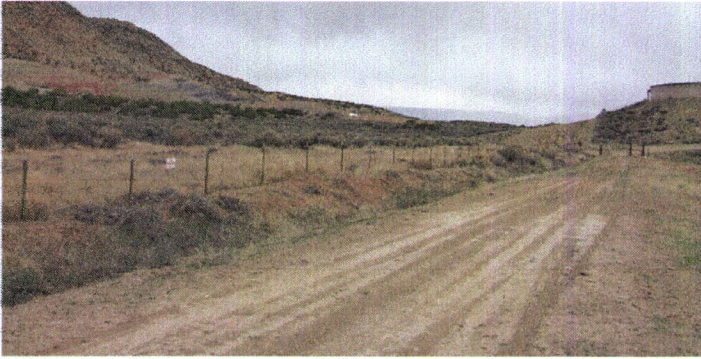
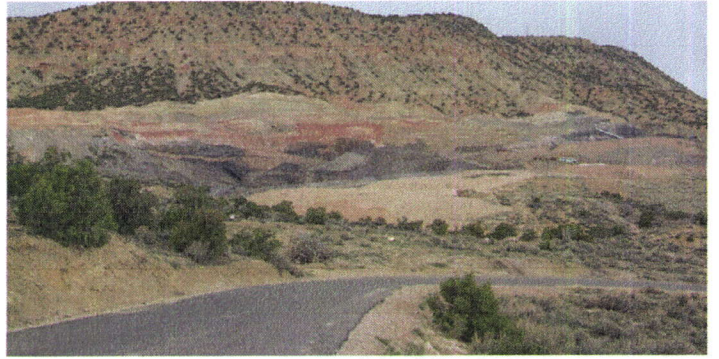
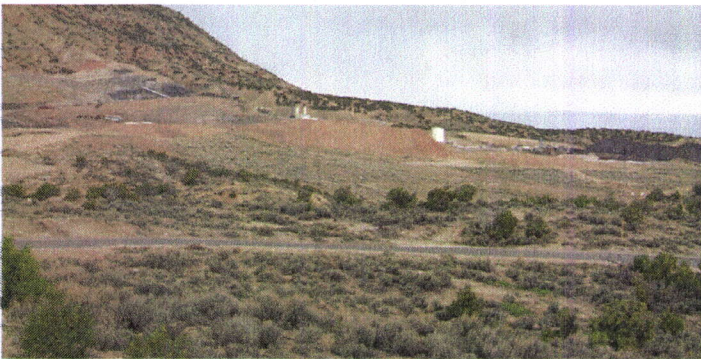
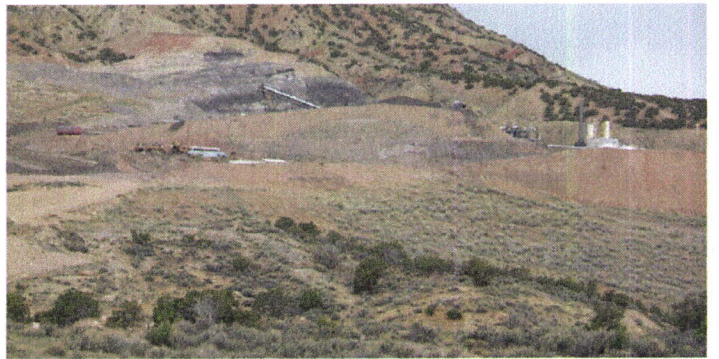
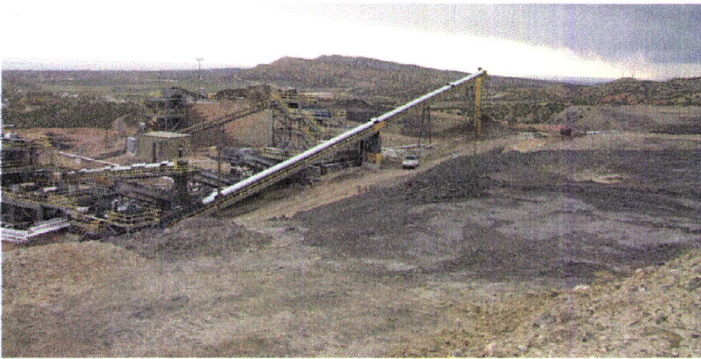
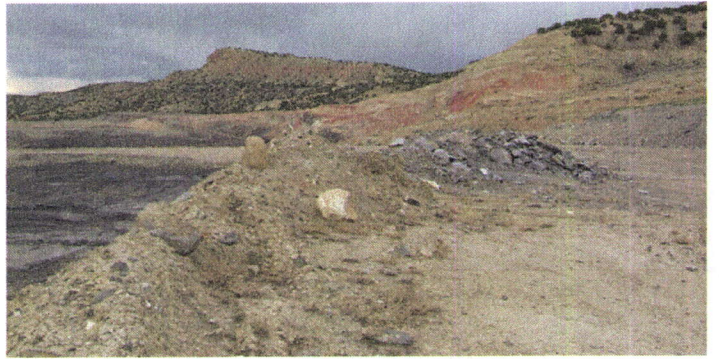
3/4 M/047/032

We then drove back on the road which leads to Air Village and took photos of the site from this vantage point. These photos include vegetation on reclaimed areas which could be released, although there are also reclaimed but unreleased areas which have been redisturbed.

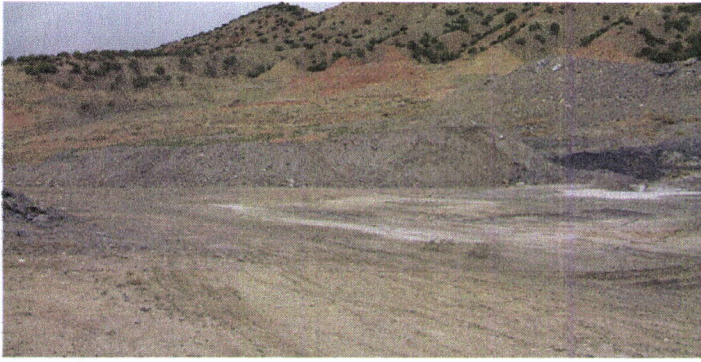
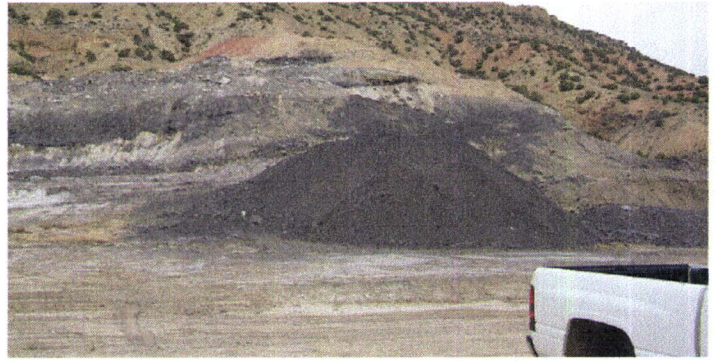
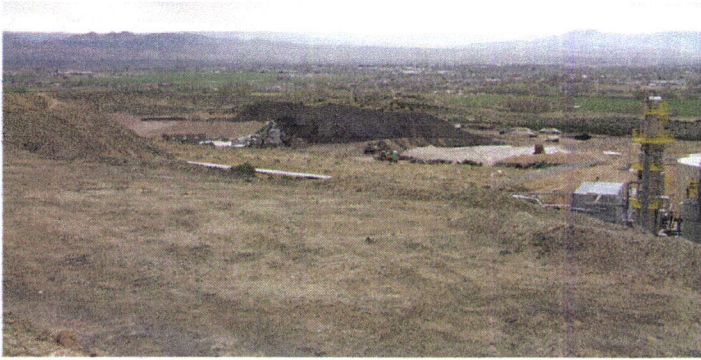
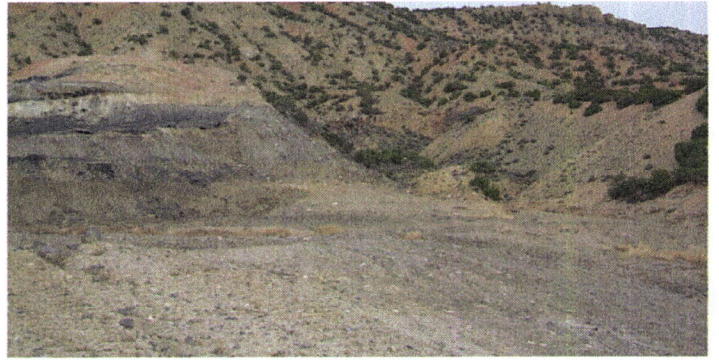
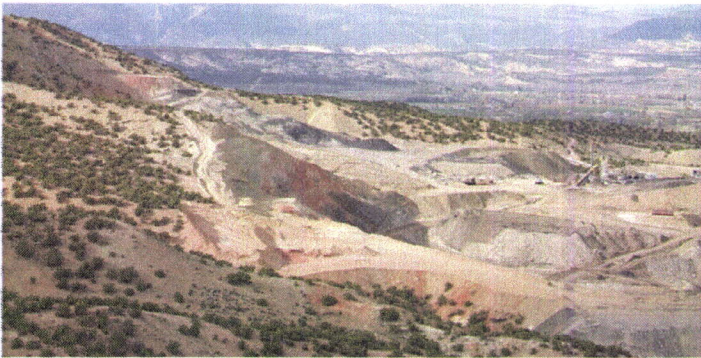
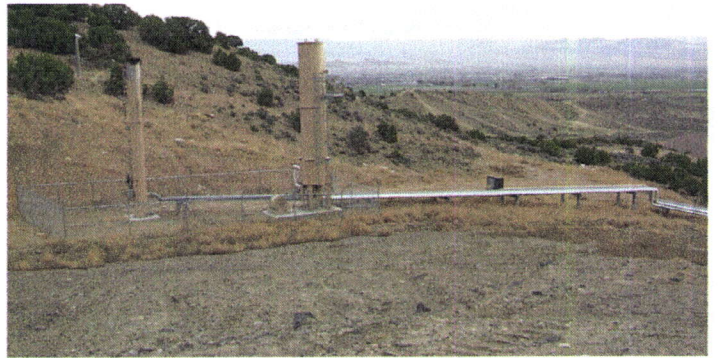
4/4 - M/047/032

We then went to the smaller mine floor located north of the main pit floor. Photographs were taken from this vantage point looking toward the west, toward the north over the drainage, and toward the east along the drainage with Crown's facilities in the background.
